## Rolling TriAx out across Queensland

Tensar TX160 is helping to repair roads damaged by storms and floods in towns along North Queensland's coast.

### Soldiers Road

Subgrade Stabilisation

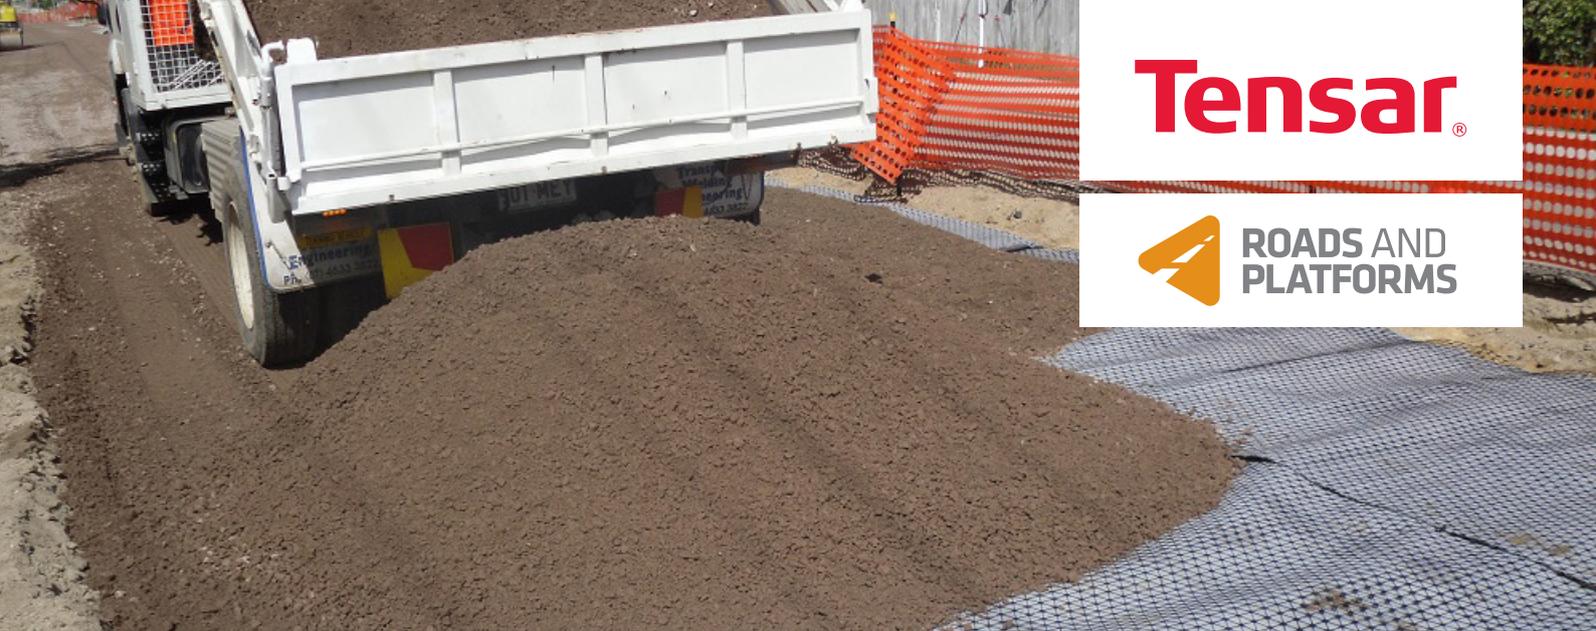
The success of this trial, on Soldiers Road, saw the method adopted by the council on roads across the region.

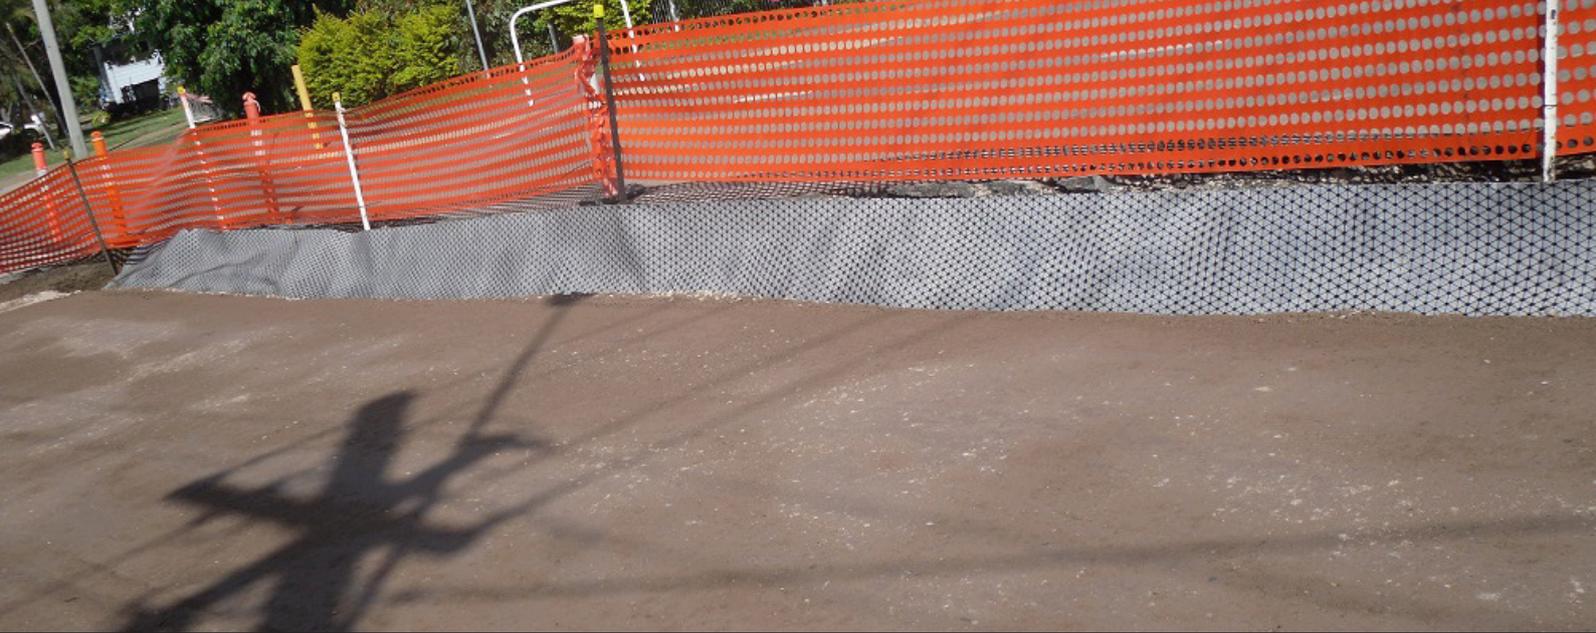
The success of this trial, on Soldiers Road, saw the method adopted by the council on roads across the region.

The approach was trialled on Soldiers Road, one of the worst affected routes in Bowen. A composite laminated product of TriAx geogrid and a separation geotextile (to prevent fines moving up into the pavement structure) was used, as it was faster than installing two separate layers.
